Final Site Photograph Album

# SITE PHOTOGRAPH ALBUM NAVAL WEAPONS STATION YORKTOWN CONTRACT TASK ORDER 0018

# Naval Weapons Station Yorktown Installation Restoration Program Site Photograph Album

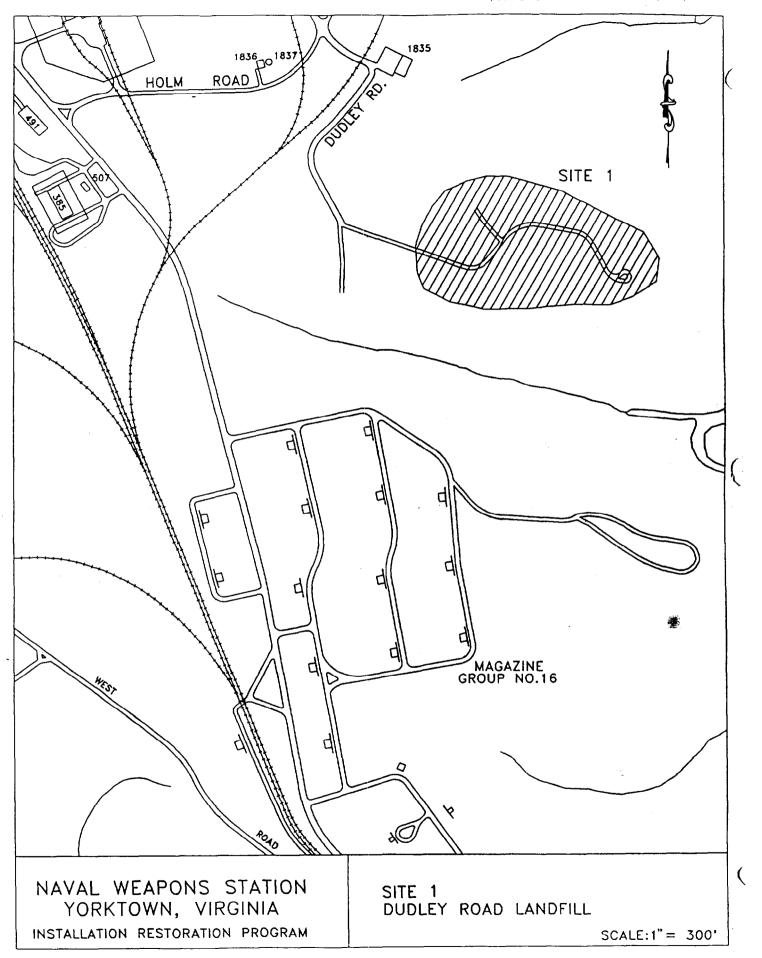
#### Site 1: Dudley Road Landfill

The area is now covered with scrub grasses and immature trees. Areas in the vicinity have been used as borrow areas (where soil is removed or "borrowed") to cover the landfill, and have similar vegetative cover. The landfill has a manmade cap (cover), though it is reported to have some pock-marks and sink holes, possibly due to insufficient methane control or insufficient compaction of the dirt cover. Downgradient and northwest of the landfill is a former waste oil pond that was cleaned out and currently is filled with accumulated precipitation. A former sand reclamation pit is also situated near the landfill, but was recently filled with leftover dirt from a railroad track widening process.

The first photograph, an aerial shot of the Station, illustrates the locations of sites 1,3,11 and 17. (Site 3 is the Group 16 Magazines Landfill; Site 11 is the Abandoned Explosives Burning Pit and Site 17 is the Holm Road Landfill). The aerial illustrates the site location relative to the York River (to the left). The second aerial provides a closer view of the landfill.

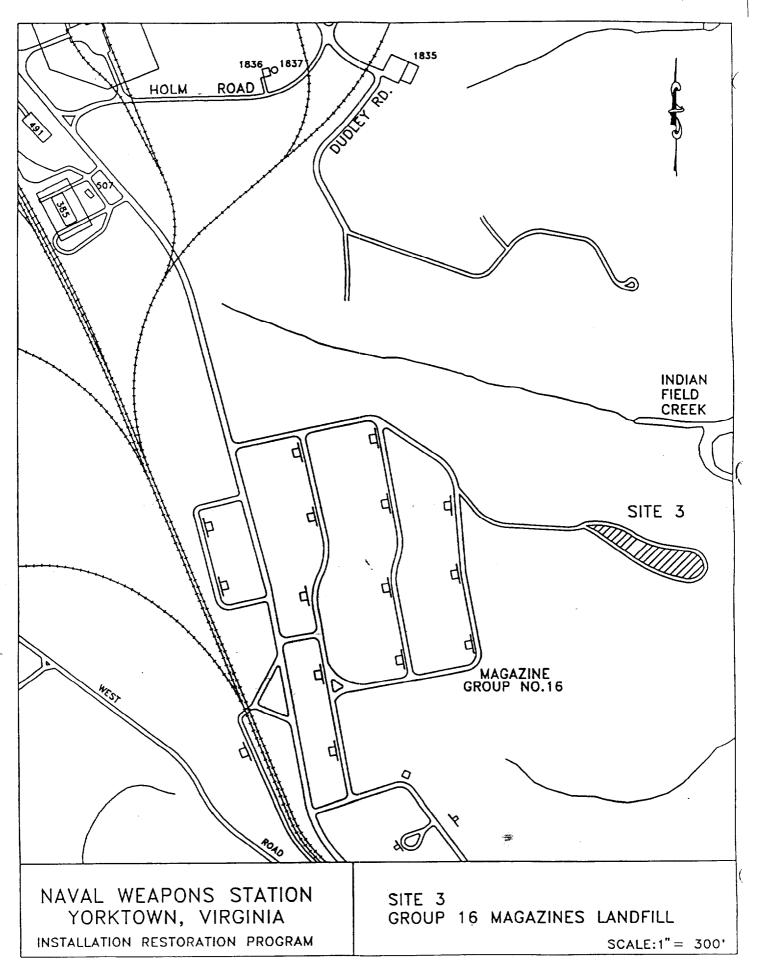
# Site 3: Group 16 Magazines Landfill

The vegetative cover in the dump area consists of grasses and young trees. Surrounding the fill area is mature forest cover. The actual boundaries of the landfill are not easy to define, despite the disturbed areas. There is little evidence of the existence of the dump due to the cover; however, some scrap sheet metal is visible in the grass. A nearby channel of Indian Field Creek is the surface runoff receptor for the site. It is assumed that the groundwater flow direction is also towards Indian Field Creek.

In the aerial photograph, Site 3 is in the lower right hand corner. The small clearing in the mature forest area is visible. The next four shots provide a closer view of the area.

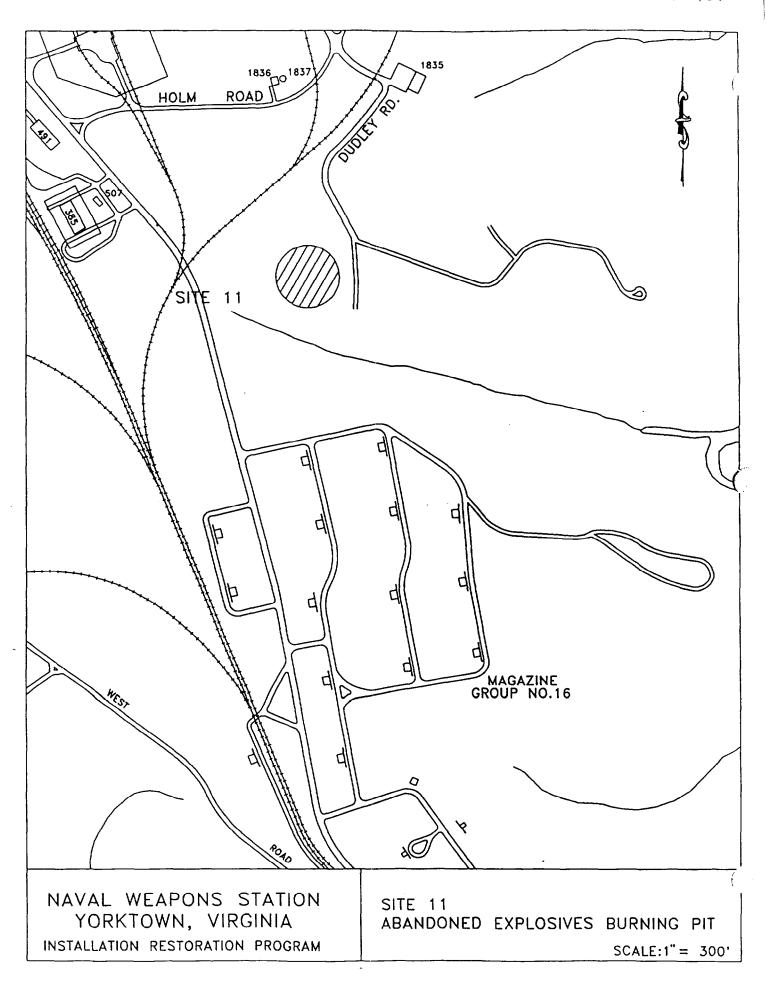
# Site 11: Abandoned Explosives Burning Pits

This approximate 0.5 acre area has a 20 year history of burning ordnance and ordnance-contaminated wastes, from 1930 to 1950. Ashes and residues from the open burning of TNT, RDX, and HMX wastes, contaminated wastes, and contaminated sludges are suspected to be present at the site. An estimated 200 pounds of explosive waste residues may have been disposed at this site. The site is forested with pines and brush such that the actual boundaries are difficult to ascertain.

The following photograph illustrates the clearing in the woods, where recent growth delineates the explosives burning pits.

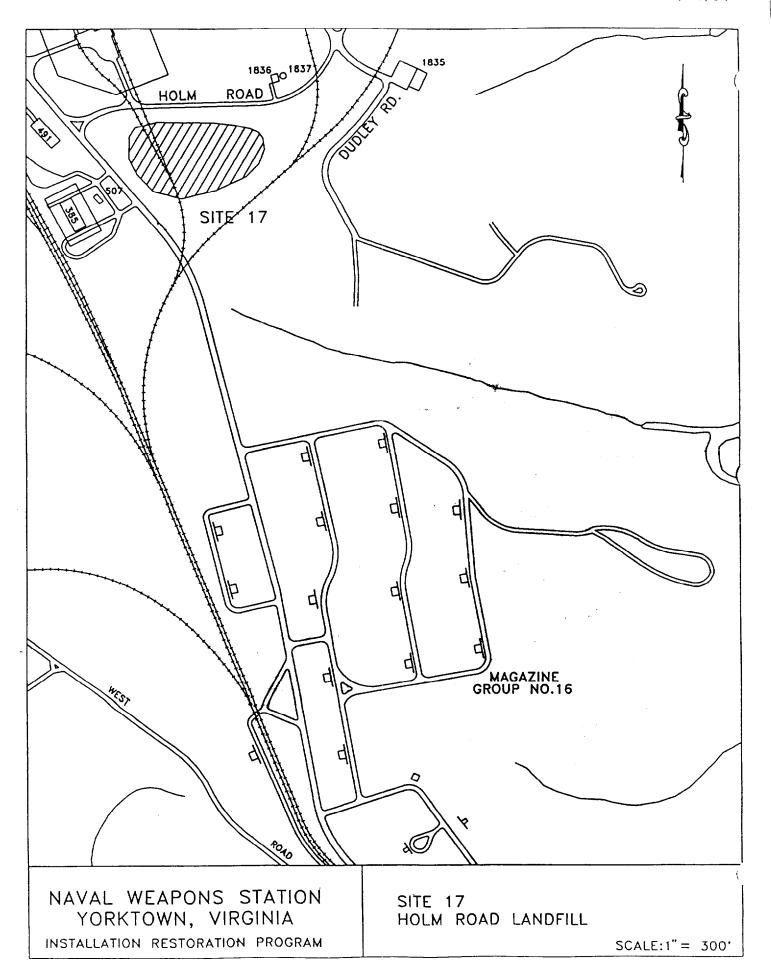
### Site 17: Holm Road Landfill

Recent field inspection could not support the previous report (1984 IAS) of numerous drums on site. No visible waste was observed. Vegetative cover is mature trees which delineated the landfill boundary. Groundwater flow is eastward to a tributary of Indian Field Creek. Surface water drainage is assumed to be primarily northward, towards a tributary of Indian Field Creek, and will be confirmed at a later date.

This photograph is of a monitoring well adjacent to the site.

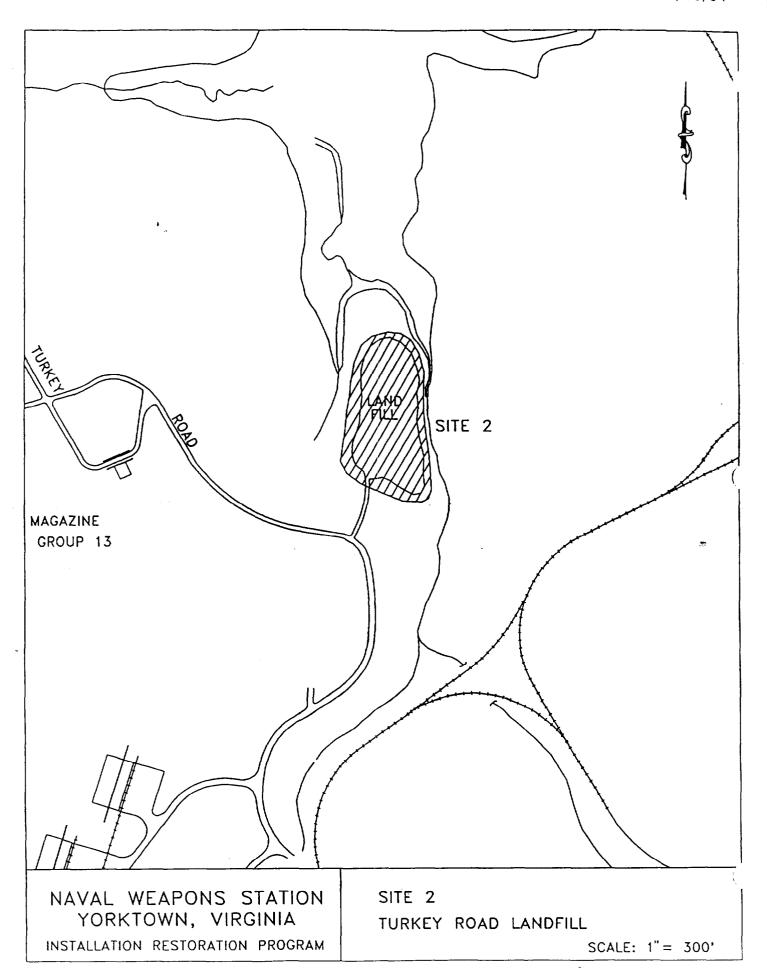
### Site 2: Turkey Road Landfill

The steep banks do not allow tidal wash onto the site; trash is visible along areas of the creek banks. Drain pipes were noted along the banks and are thought to be draining from nearby Turkey Road. The site itself is covered by scrub vegetation, and a few small trees, and contains numerous sink holes, most likely from lack of compaction of the waste materials.

An aerial view of the landfill is presented in the first and third photographs while the second view is of the site during the summer. The last four pictures focus on the wastes disposed, in particular, scrap metal.

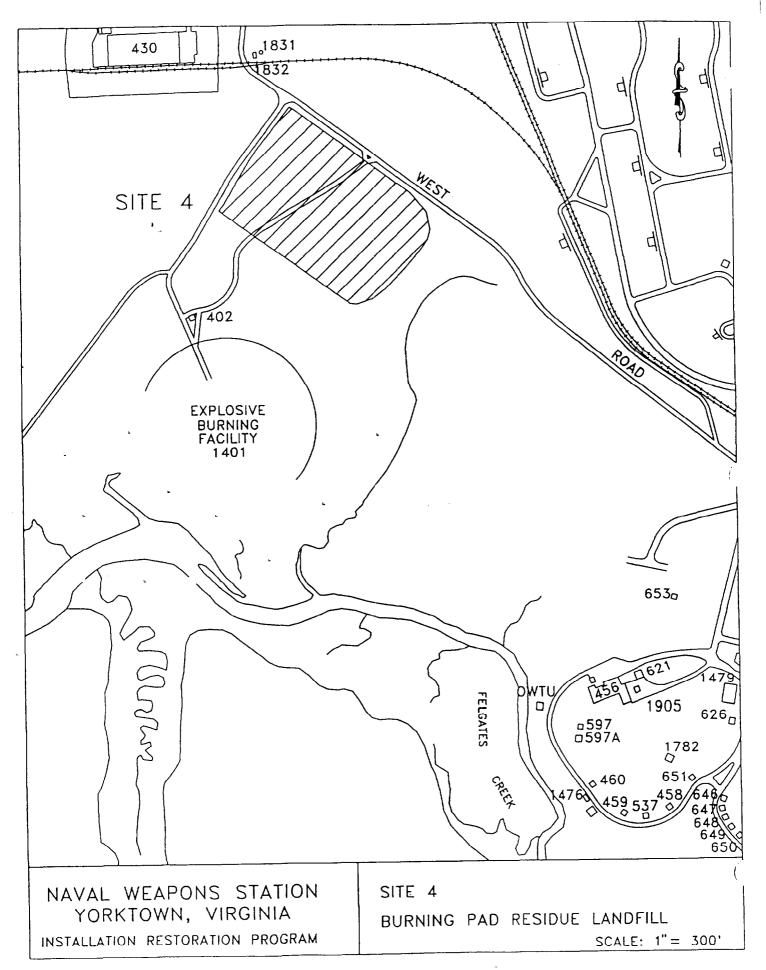
# Site 4: Burning Pad Residue Landfill

The site is primarily a cleared area with scrub grasses and some small trees. The site has an area of ash mixed with soil cover. This area is near an embankment edge. The remainder of the field is covered with grasses, and across the embankment is mature forest cover. Groundwater flow is southwesterly to Felgates Creek. Surface water flow is either easterly towards a tributary leading to Felgates Creek or southwesterly to Felgates Creek. Access to the site is restricted, but there are no fences or other barriers around the site.

The first photograph locates the site relative to the current burning pad facility and Felgates Creek. The actual residue is illustrated in the next picture while the last photograph is a closer view of the site and the current burning pad facility.

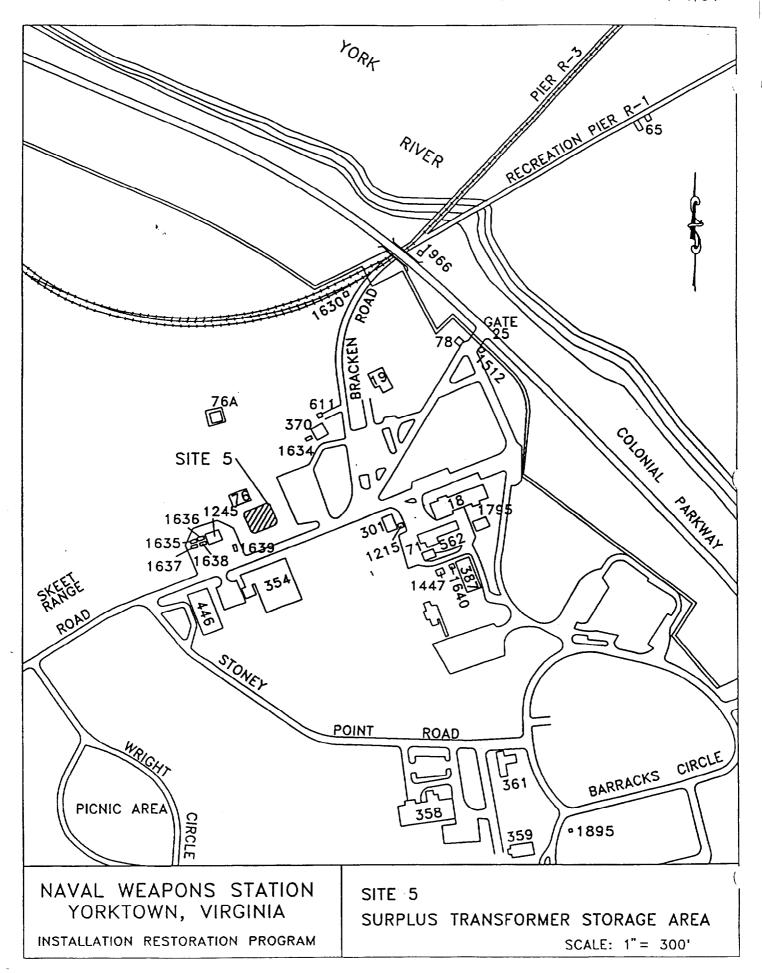
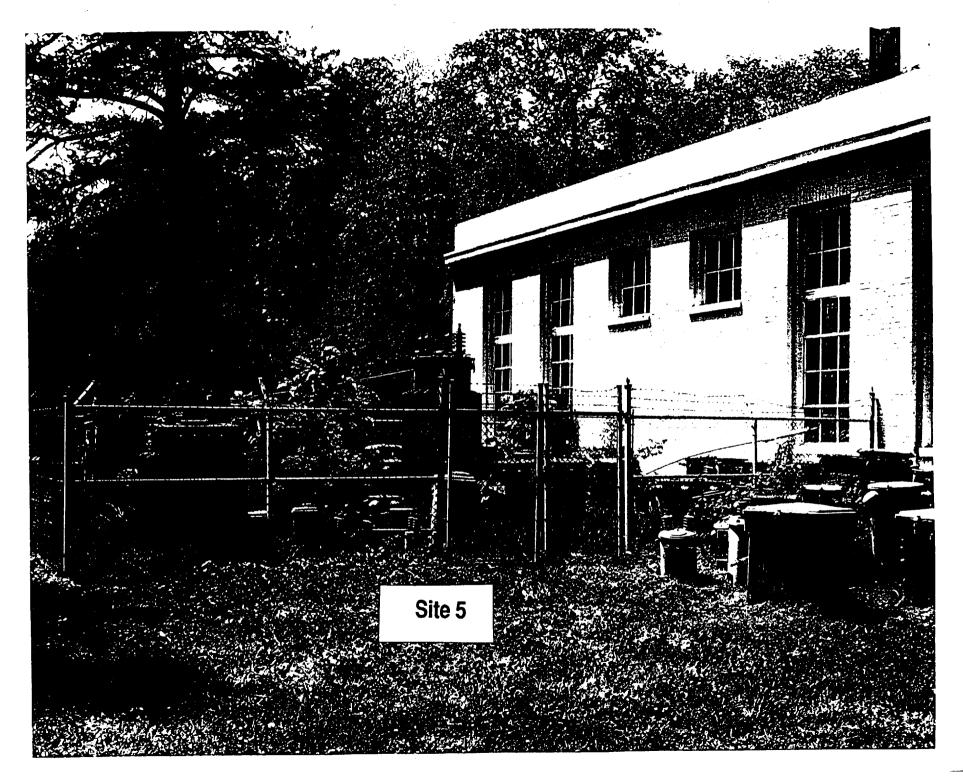
# Site 5: Surplus Transformer Storage Area

The site is fenced and the transformers sit on either of two concrete pads or on slotted, metal pallets. Grasses and a young tree grow inside the fenced area. There appears to be no containment for spills.

An aerial photograph provides a view of the area as it was used in the past. The second photograph is of the building. The last picture is of a leaky non-PCB transformer.

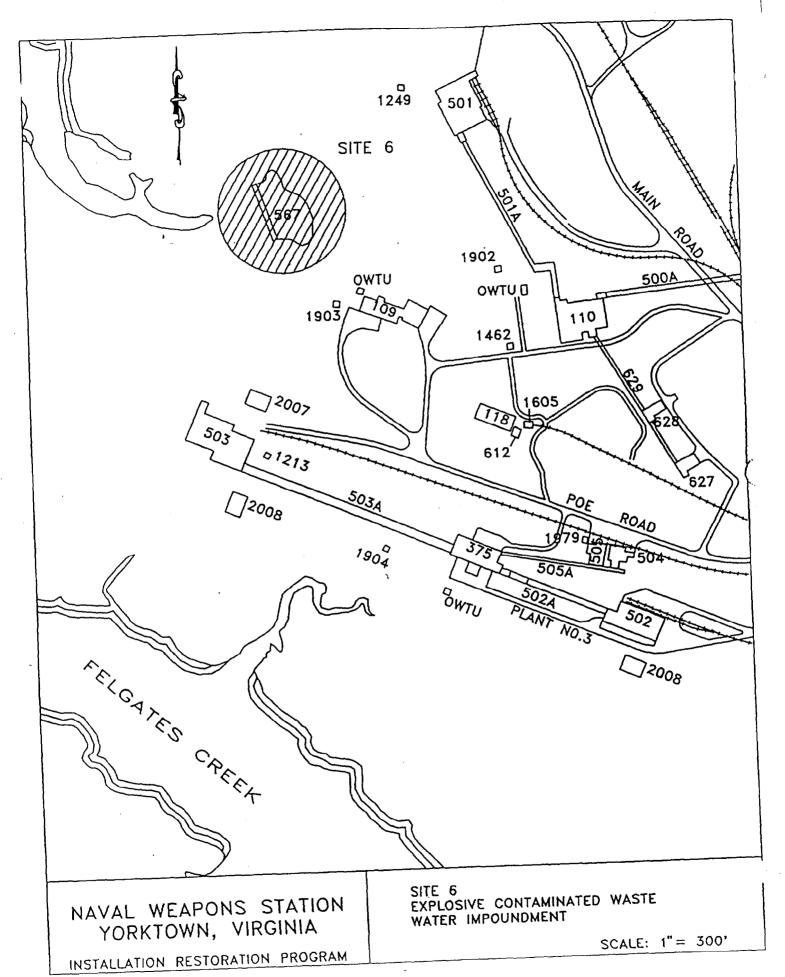
### Site 6: Explosive-Contaminated Wastewater Impoundment

In the first photograph, the site is located in the top right hand corner, in the woods. The second shot is of the drain pipe. The third picture shows the retaining wall of the impoundment with the tidal area behind the wall.

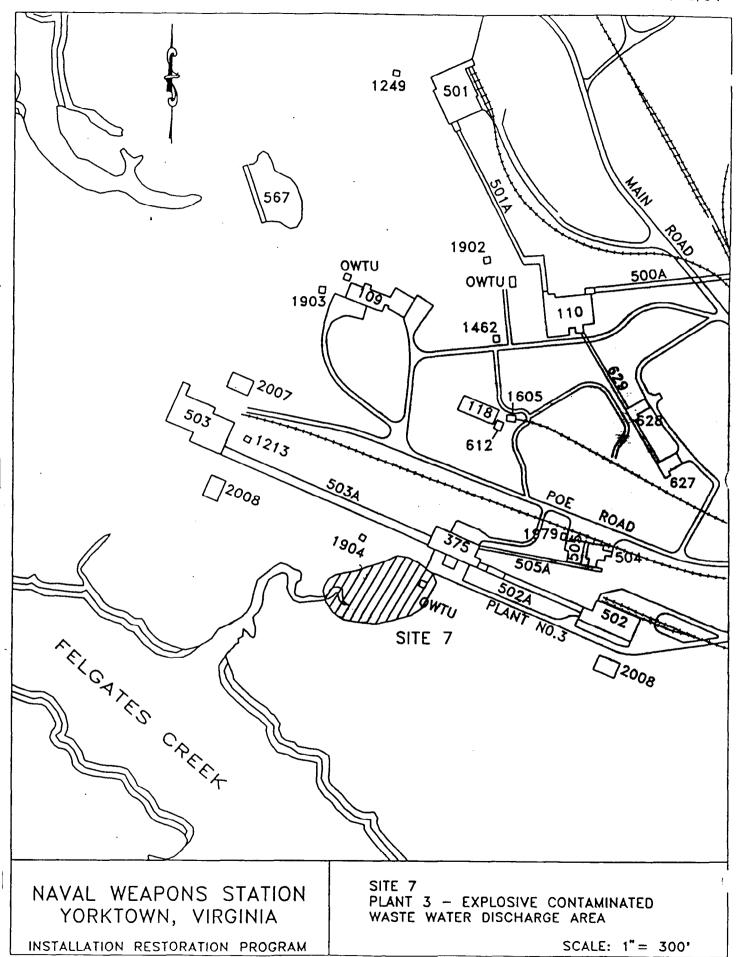
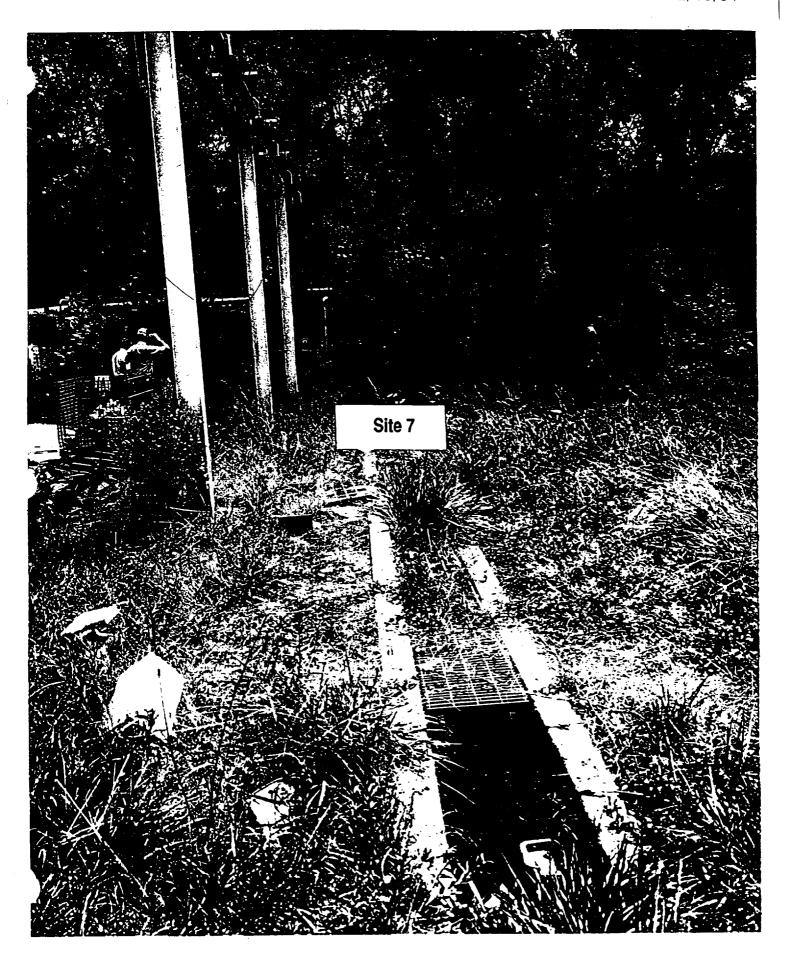
### Site 7: Plant 3 Explosive-Contaminated Wastewater Discharge

This first photograph locates the site, next to the white building, with respect to Felgates Creek. The next two photographs are of the drainage culvert from the floor drain. The white pipes for carbon treatment of the wastewater are in the upper left corner. The last pictures show a closeup of the culvert and the woods in the area.

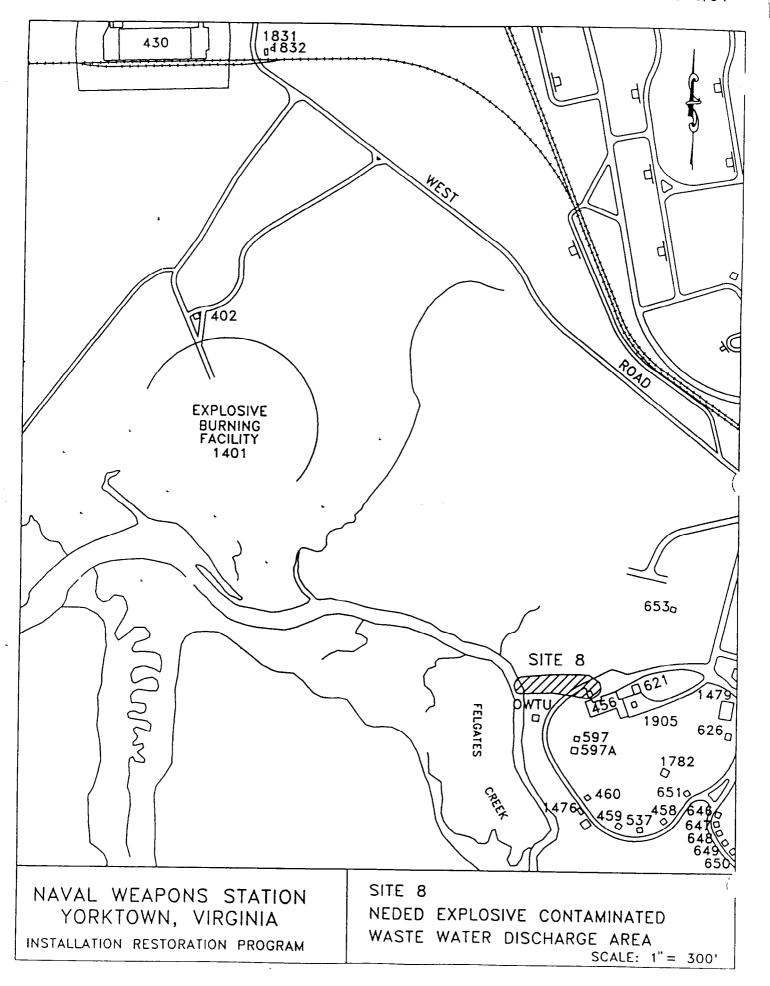
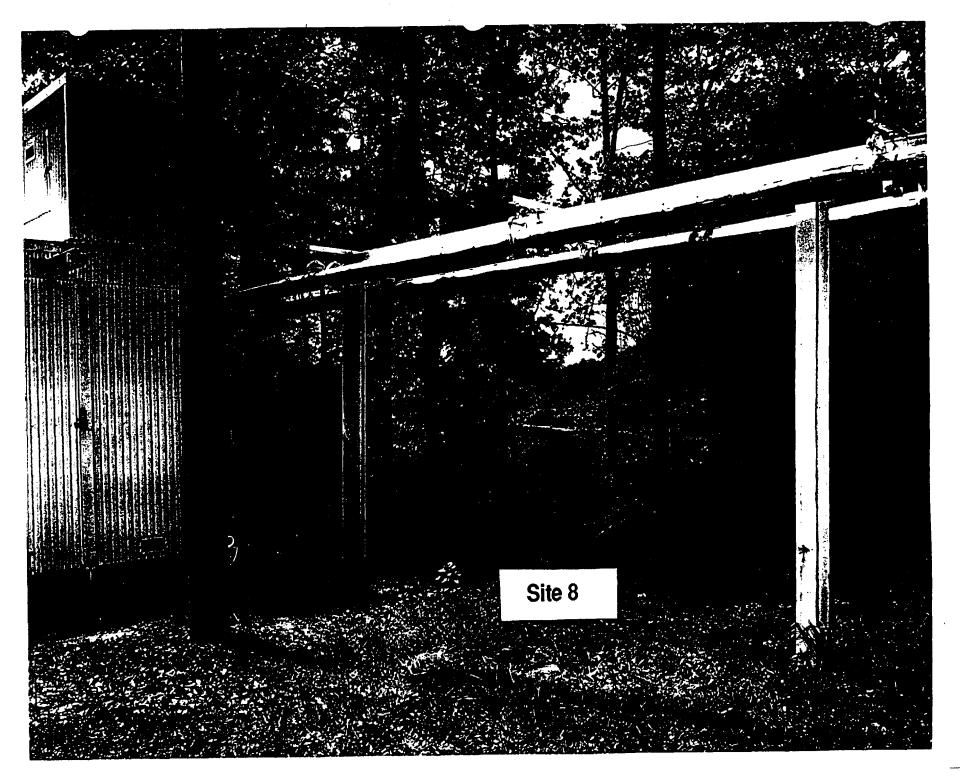
## Site: 8 Naval Explosives Development Engineering Department (NEDED) Explosive-Contaminated Wastewater Discharge Area

The first picture was taken looking at the drainage area from the hill. The second photograph is of the drainage pipe. Surface water runoff and precipitation are the only water types presently in the area. The last two pictures are closeups.

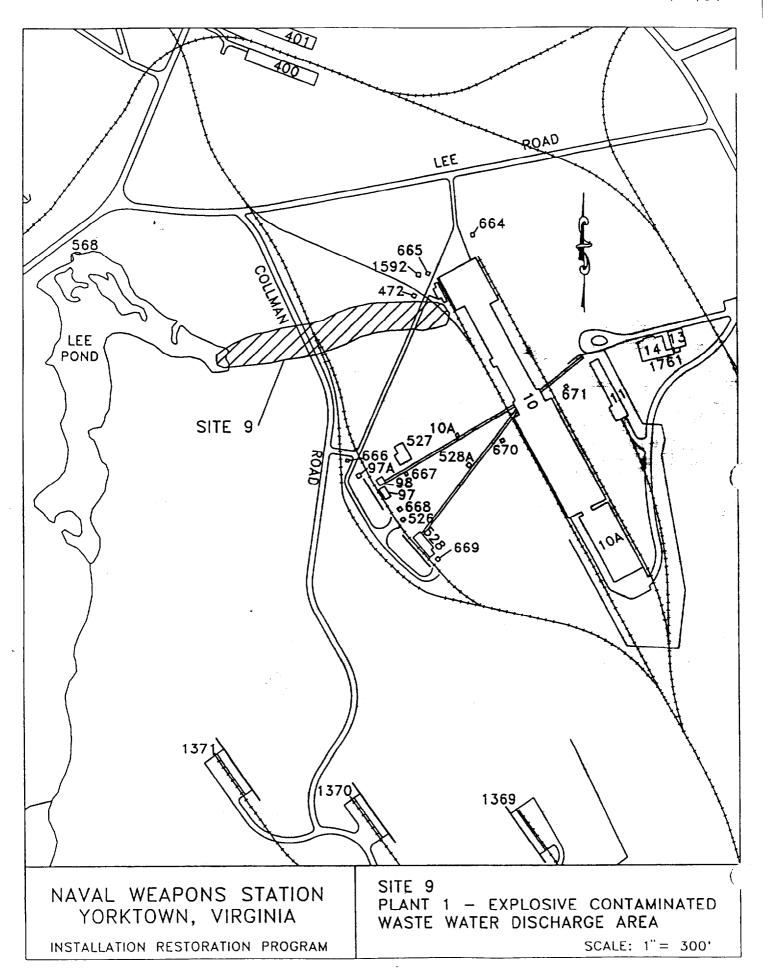
#### Site 9: Plant 1 Explosives-Contaminated Wastewater Discharge Area

A drainage ditch leads the wastewater discharge from Building 10 to the Site 9 area. The area is wooded and sloped, with a fenced access. Two culverts mark the beginning of the drainage area which is usually moist to wet. Just above the point where the water pooled, a small pile of 30-gallon drums and rail road ties were noted.

The first photograph is an aerial of the site while the second is a closeup of the drainage ditch.

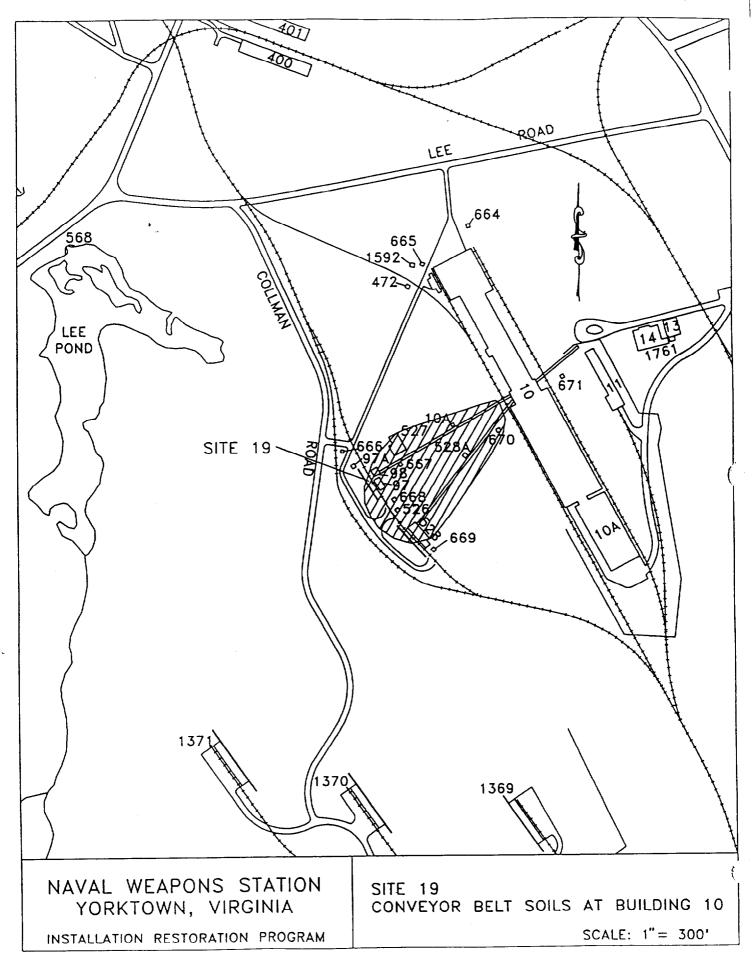
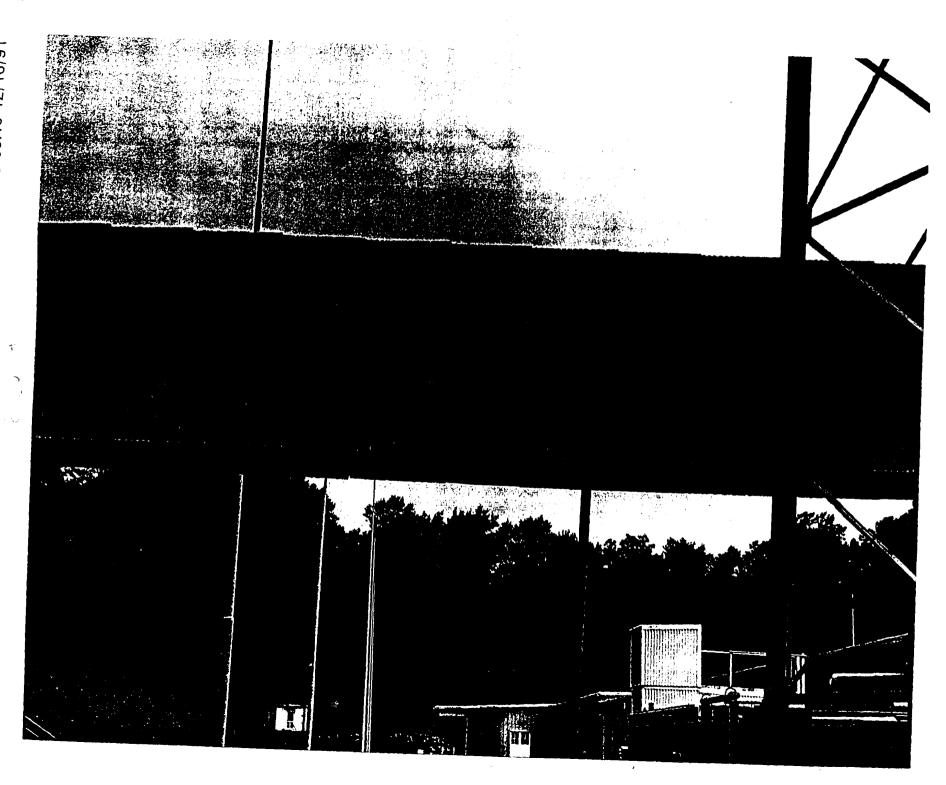
## Site 19: Conveyor Belt Soils at Building 10

The conveyor belt (Site 19) carried TNT powder across a gully into the loading building. The conveyor belt is completely surrounded by walls of corrugated metal, but holes are visible in the walls and floors. TNT dust settled on the soils below. The conveyor and walls/floor were sprayed with water to lower the levels of the powder dust. This rinse water dripped onto the ground below and into the adjacent ditch and rail road tracks at Site 9. The soils were primarily contaminated with TNT flakes, which spilled from the boxes being transported between buildings on the conveyor belt.

In the aerial picture, the encapsulated conveyor belt can be seen extending from the white building. The second and last photographs are closeups of the tunnel.

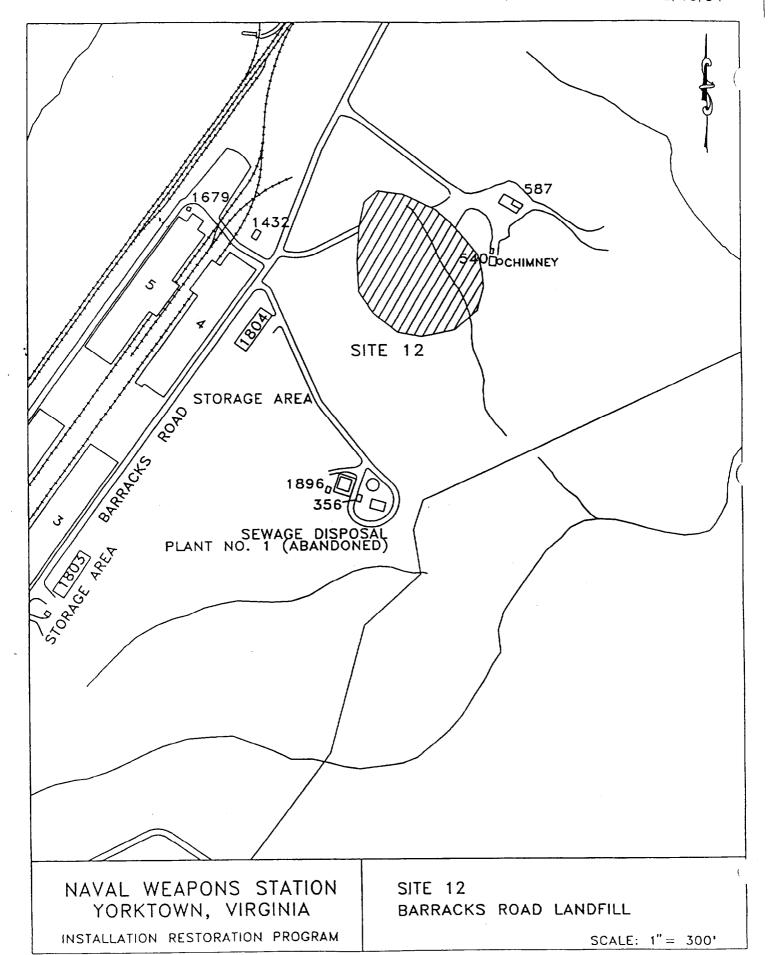
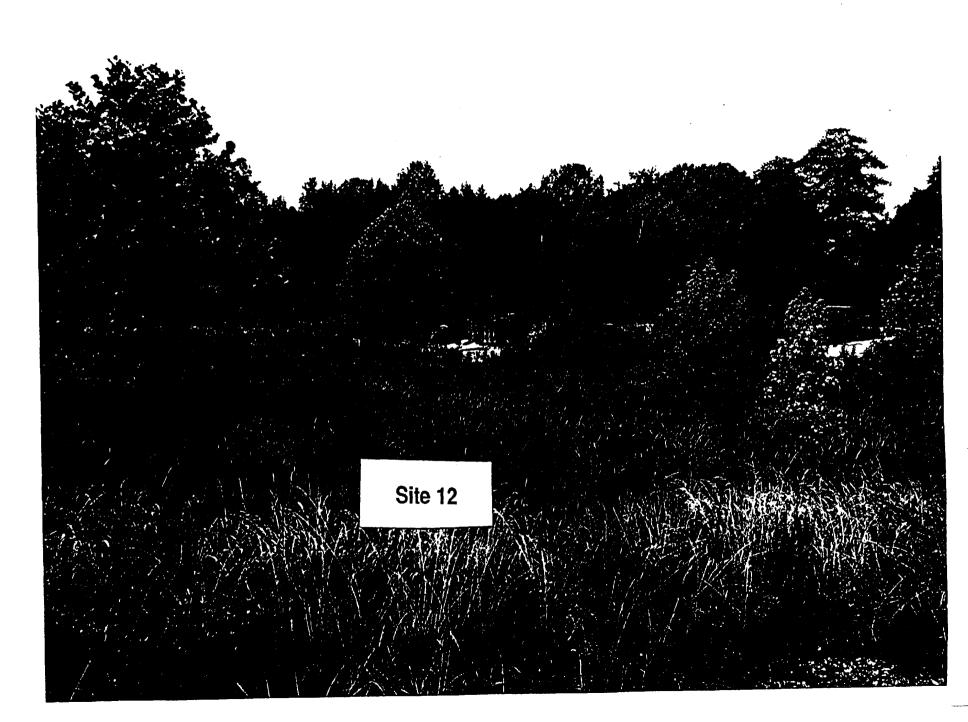
#### Site 12: Barracks Road Landfill

Field inspection showed some evidence of the wastes -- scrap metal, drums, and several tires -- scattered at the sloping edge of the ravine. Two small drainage courses, originating at the landfill, meander through the vegetation to the tributary. Where drainage eroded the cover soil, scrap metal and glass are visible. Reported wastes of this landfill include mostly garbage, refuse, scrap wood, small medicine bottles, and some explosive-contaminated packaging. Trash from incoming ships also was burned in the incinerator. Resulting ash was placed behind the incinerator and contributes to contaminated discharge into Ballard Creek. As this landfill is the predecessor of the Dudley Road Landfill, it is likely that wastes similar to those identified at Site 1 were also disposed at this site, including solvents (i.e., trichloroethylene, trichloroethane, and methyl chloride).

In the aerial photograph, Barracks Road landfill is located in the center, to the right of a currently utilized trash pickup area. The second photograph shows the perimeter of the landfill, looking at the above mentioned area while the third picture is illustrating the wastes disposed.

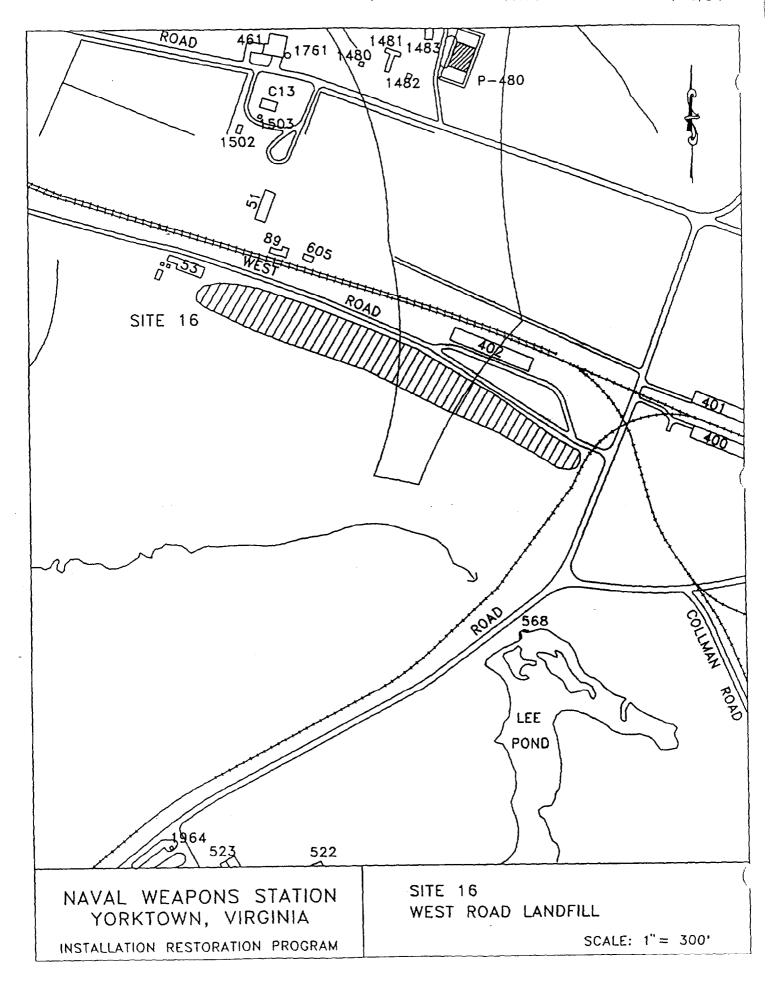
### Site 16: West Road Landfill

A portion of a large scrap metal pile, reported to have reached two stories high, was possibly pushed into these woods for disposal several years ago. Field inspection notes a pile of scrap metal objects, including missile hardware. A pile of approximately 18 foot long twisted metal pipes, possibly containing asbestos, was noted. Thirty-gallon drums, rotting batteries, chemical bottles and miscellaneous electrical devices were also identified.

The first photograph is a closeup of the batteries found at the site while the next is a historic aerial photograph of the former scrap pile near the site. The landfill is in the woods at the top of the picture. The following photographs illustrate some of the wastes present: drums, scrap metal and batteries.

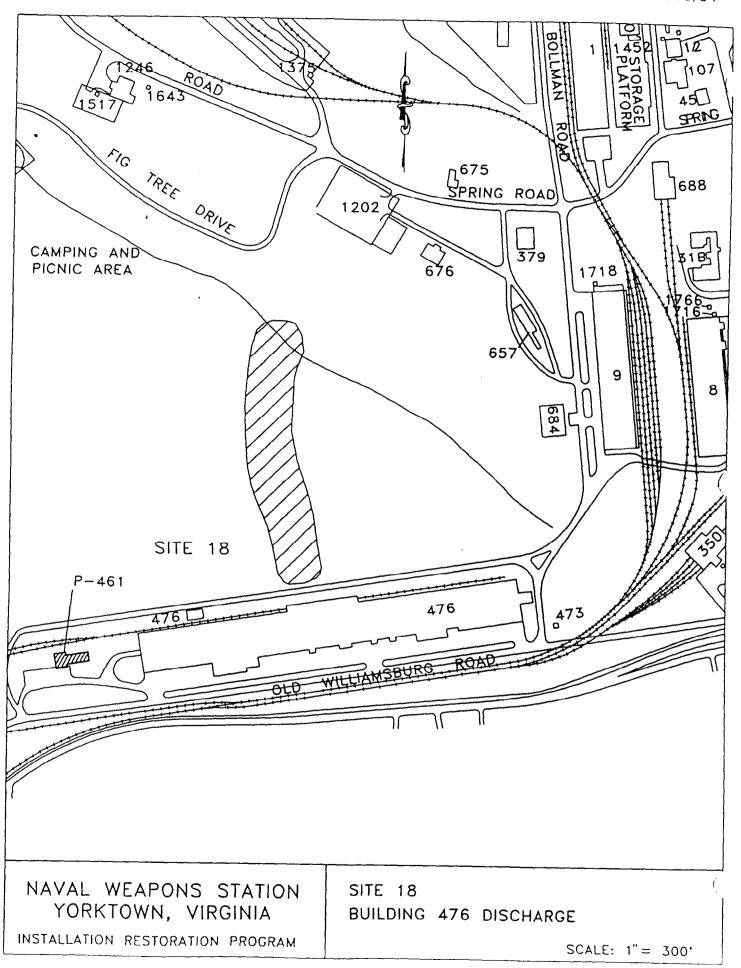
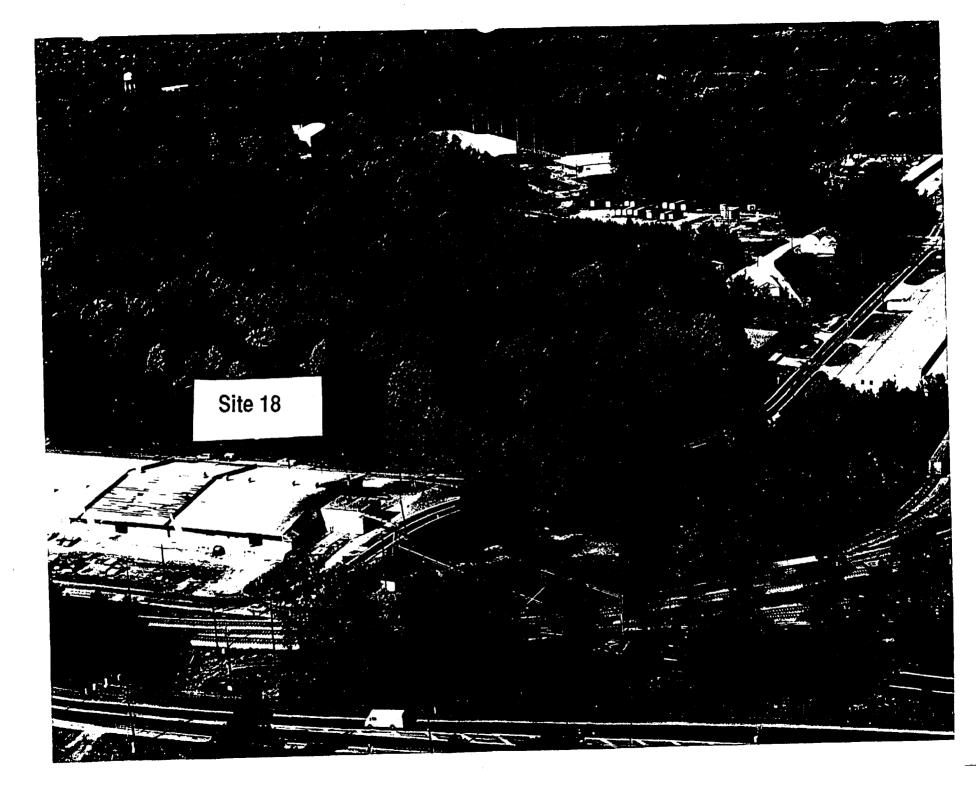
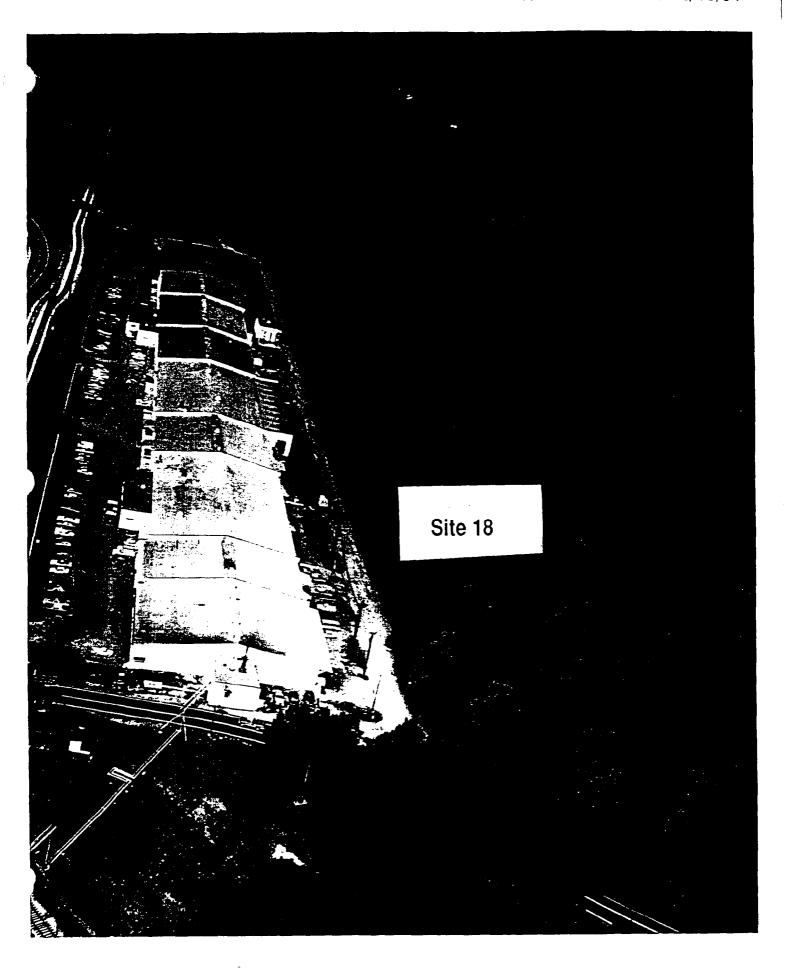
# Site 18: Building 476 Discharge

A 24-inch diameter drainage pipe at the head of the ditch was noted during the field inspection. It is thought to convey storm water collected from the parking lot of Building 476. The ditch had approximately four inches of water at its origin; it appears to meander naturally, becoming an intermittent stream that drains into Lee Pond. At its widest point noted, it was about 10 feet across and had approximately 4.5 feet of water.

The first aerial photograph locates the site in the woods along the right side of Building 476. The next picture is of the drainage pipe at the head of the ditch. The liquid is water, most likely from precipitation. The last shot is another aerial view, taken in the summer.

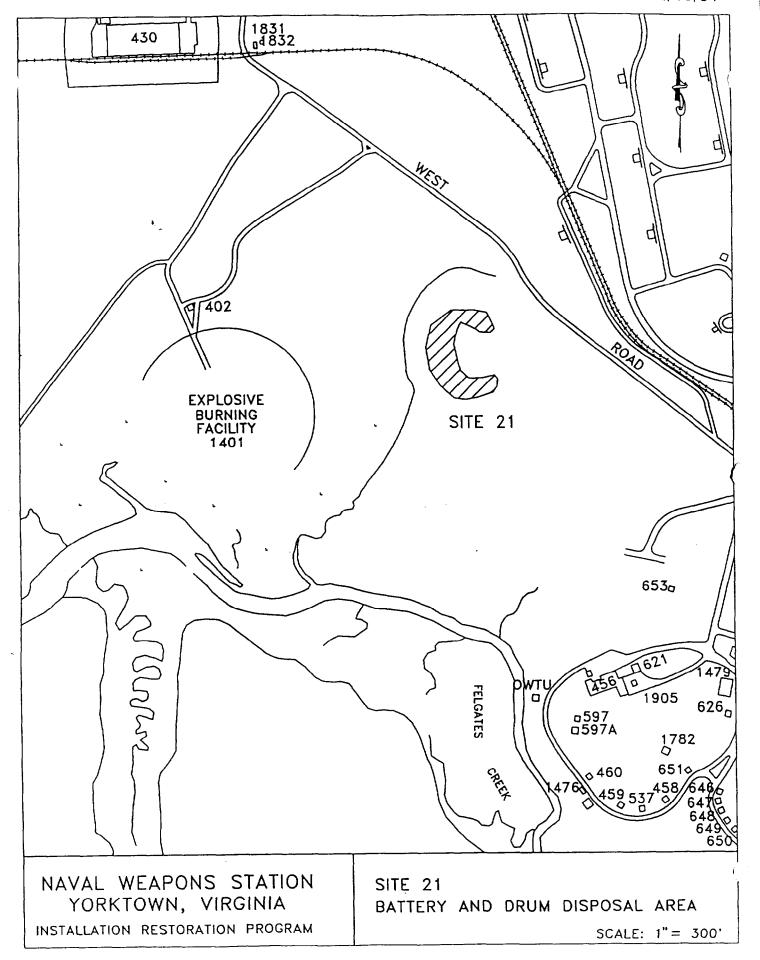
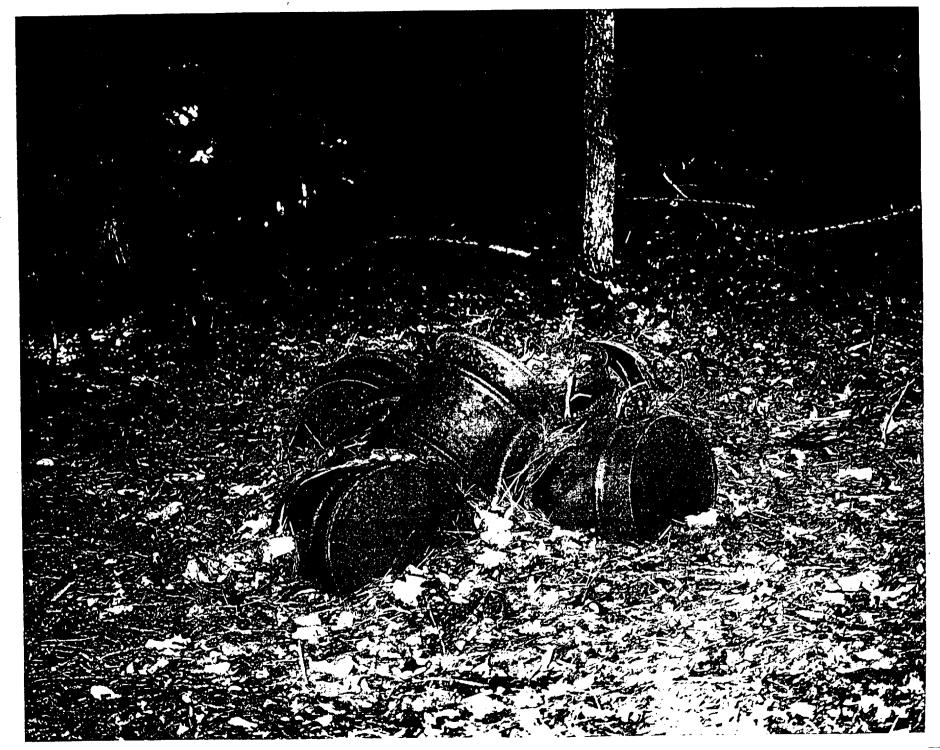
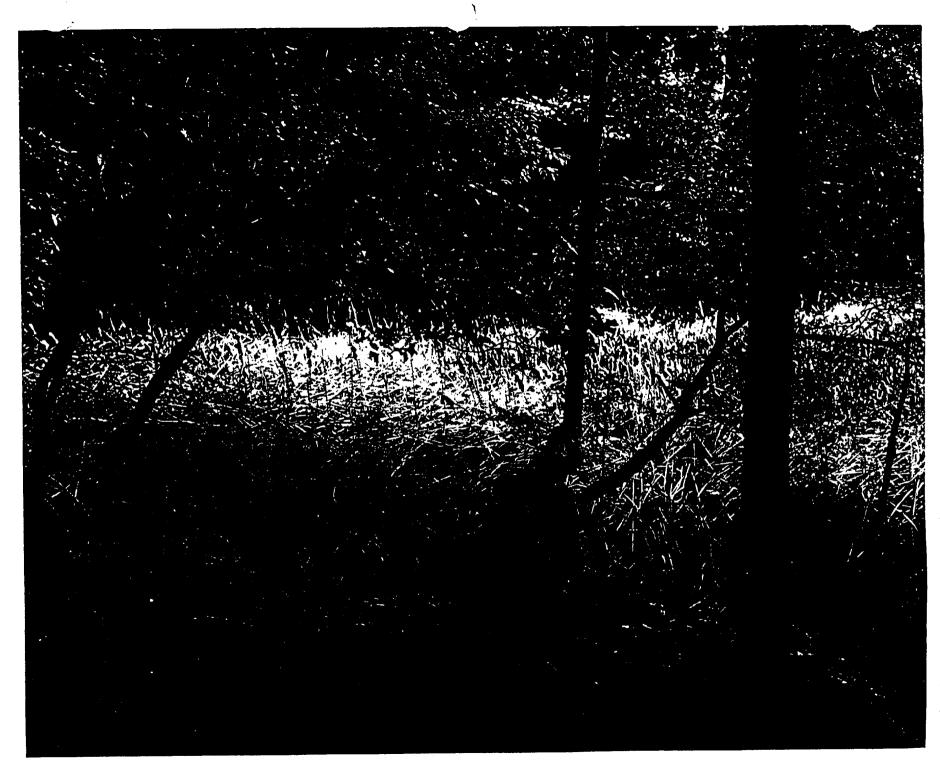
## Site 21: Battery and Drum Disposal Area

Site 21 is a recent addition to the IRP. Currently, the site is undergoing a Preliminary Assessment/ Site Inspection. It is a former dump located in and adjacent to an intermittent stream valley. Material at the site was dumped randomly on a hillside that slopes to the stream. Observations of materials at the dump include: five and fifty-five-gallon drums; cans; cables and wires; rubber hoses; scrap pipe and timber; and decomposed military batteries. The first three photographs are closeups of the materials while the last is a general shot.
